# Reconditioning the Teebus sluice gate

This article, by Leanne Matthysen and Jan Lourens of Thermaspray; Volkmar Kohlmeyer and Jan Adriaan Nel of the Department of Water Affairs; and Hugo Howse of United Surface Technologies, describes the reconditioning of the sluice gate wheel, shaft and assembly at Teebus on the Orange-Fish Tunnel.

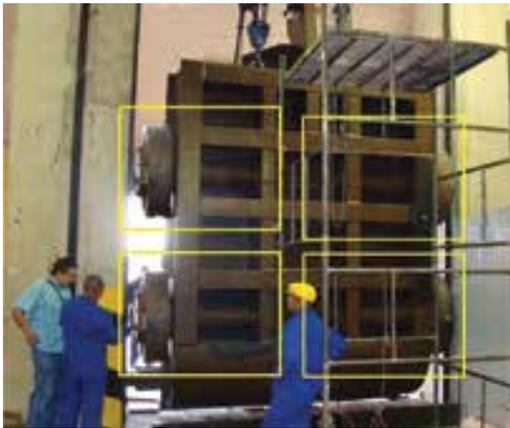
**Figure 1:** Shaft assemblies prior to reconditioning at Thermaspray.

Recently, the sluice gate wheel, shaft and assembly at Teebus (**Figure 1**) were removed for reconditioning and repair work due to severe deterioration of the components. This is the first work performed on the sluice gate wheel assembly since its installation some 37 years ago.

The sluice gate assemblies are moved very infrequently, ie, on average only once every five years. During this prolonged stationary period, significant damage to the wheel assembly results due to: crevice and electrolytic corrosion between cover plates and wheels, shafts and rollers; general corrosion due to the stationary position; the failure of lubricants after extended periods of immersion; mechanical and adhesive wear damage due to inadequate lubrication when the wheels were forced into motion; and wear damage between the roller ends and the cover plates.

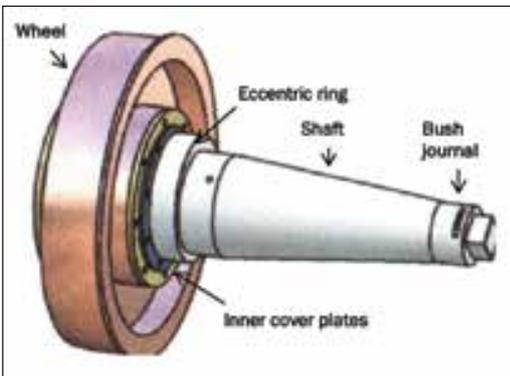
**Figure 2:** The typical sluice gate wheel assembly, which was approximately 1,4 m in length before refurbishment.

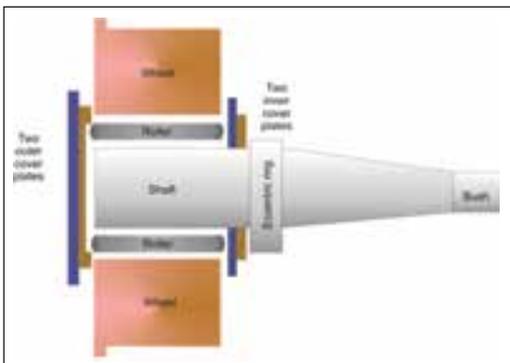
**Figure 3:** A schematic cross-section of the sluice gate wheel assembly prior to refurbishment.

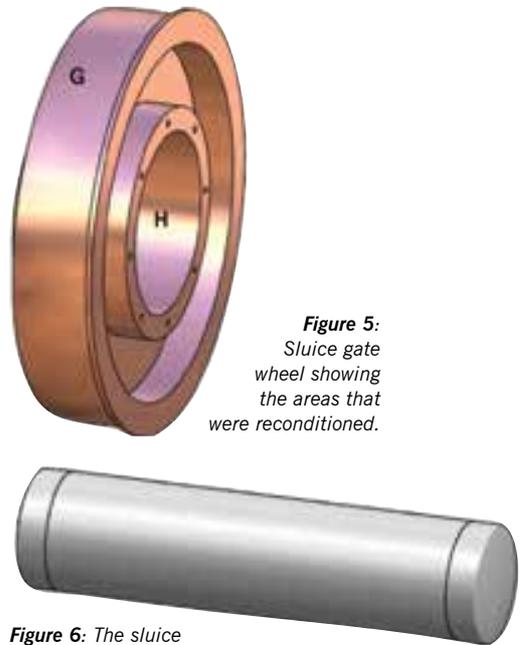
A schematic of the sluice gate shaft wheel assembly is shown in **Figure 4**. The damage on the shafts was observed to be due mainly to a combination of fatigue, corrosion and wear between the shaft and the rollers, as well as corrosion between the bush journal and the gate. The wear damage resulted from inadequate corrosion protection of the components by the hard chrome coatings on the outer diameter of the shafts (A) and the eccentric rings (C).

Severe damage, cracking of the hard chrome coating and corrosion deposits were observed on the shaft bush journals (B). The wear damage on surfaces (A) and (C) resulted from inadequate lubrication or the lack of wear resistant properties of the base materials. This situation was significantly worsened by the ingress of solids during the protracted period of no movement. The cracking of the hard chrome coating on Region B is as expected due to the porosity of the hard chrome coatings, which are inherently full of cracks. Cracks in hard chrome coatings lead to the ingress of water onto the base material and this results in base material corrosion driven by electrolytic potential.

**Figure 4:** The sluice gate shaft showing the areas that were reconditioned.

The initial reconditioning solution was to pre-machine the outer diameters (A) and eccentric rings (C) and

then build up the shaft with Stellite 6® using the plasma transferred arc (PTA) process. A thermal spray coating could not have been applied in this region of the shaft as the loads experienced by the bearing are too high.

A Stellite® 6 PTA trial, however, revealed that this method of reconditioning the surfaces was not going to be successful, due to significant variation of the 40 year-old as-cast base material. This limitation led to the manufacturing of a sleeve from ST52 seamless hollow bar. The outer diameter of the sleeve was PTA welded with Stellite 6® prior to fitting the sleeve onto the shaft at Region A. The PTA surface thus became the contact area for the rollers, improving anti-galling and wear resistant properties.

This solution required that the outer diameter of the shaft be reduced by approximately 20 mm per side prior to fitting the sleeve.

The hard chrome coating on Region B (the shaft bush journal) was machined off and a thermal spray coating alternative, namely chrome carbide/nickel chrome was recommended using the HVOF (High Velocity Oxygen Fuel) process. This coating was selected due to its enhanced corrosion and wear resistance and HVOF thermal spray coating was the most appropriate process choice.

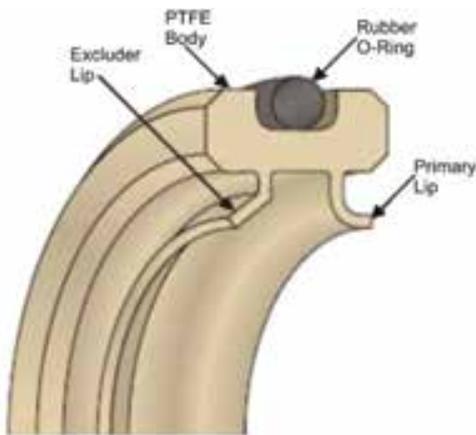
Figure 7: The custom-designed seal manufactured for the sluice gate wheel assembly.

Double lip (high pressure) seals – one double lip seal (**Figure 7**) per sluice gate wheel assembly – were inserted between the two inner cover plates to prevent the ingress of water to the roller bearing and wheel internal diameter surfaces.

The addition of the double lip seal was one of many unique development aspects to the refurbishment of the sluice gate wheel assembly. The seals were custom manufactured from Carbon PTFE and rubber material.
