**The Use of Thermal Spray Coating in Turbomachinery Applications
Technical Bulletin Ver. 1
Revision: March 2013**

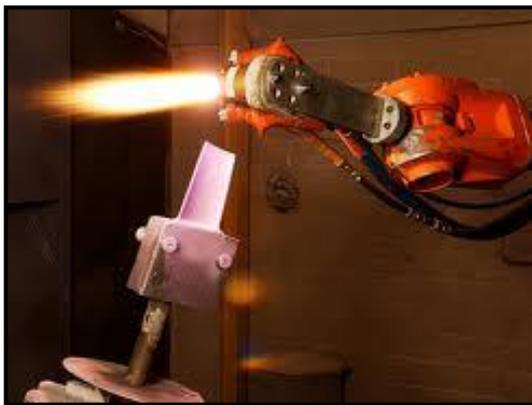
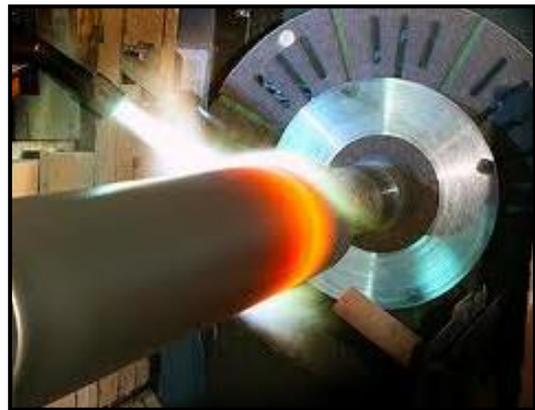
The grinding of the shafts is done in our grinding workshop, where we have several large cylindrical grinding machines (maximum 3800 mm between centres, maximum 700 mm swing), all fitted with diamond wheel grinding capability. For specific surface finishes we have two dedicated finishing lathes for the polishing and/or superfinishing of shafts.
